## STUCCO PERFORMANCE

*Residential Development*

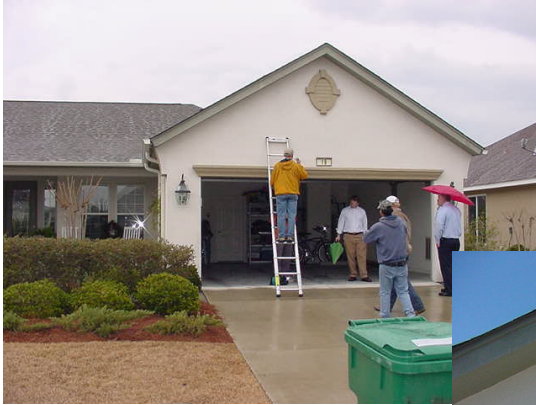
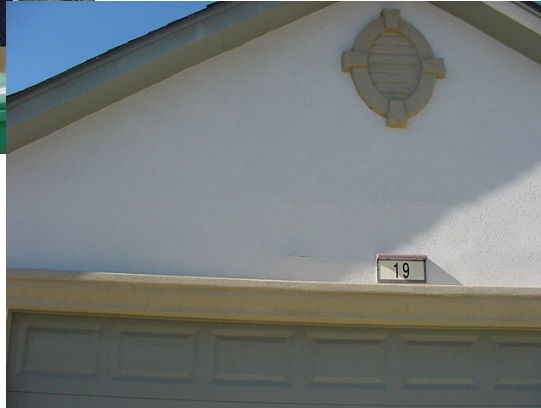
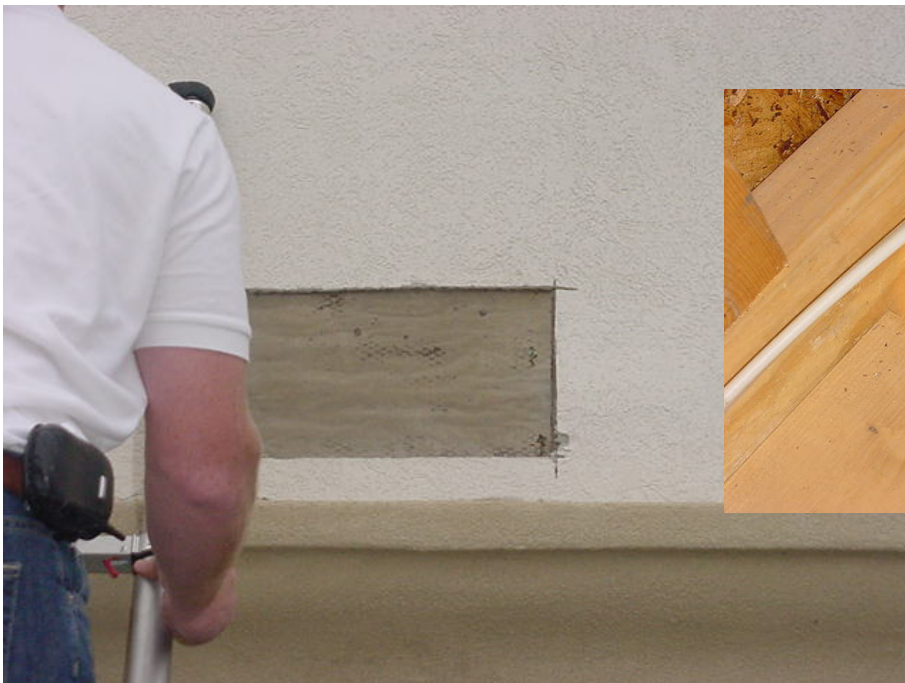
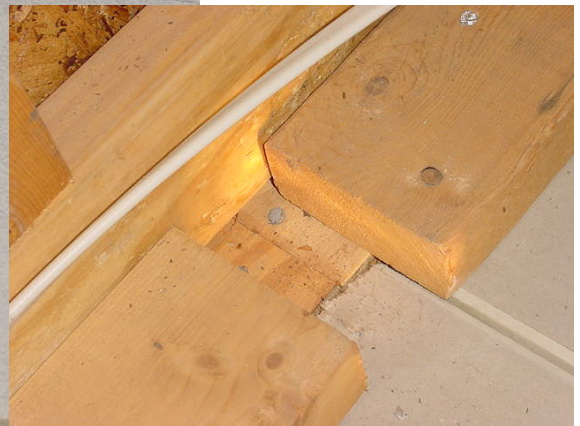
Master Wall® acrylic modified OCS was specified for these projects. Several years after installation it was noted that the stucco was bulging, bending and eventually cracking over the garage doors. Master Wall investigated the condition in cooperation with the builder and applicator.

Test cuts were taken of the exterior and the interior was examined. We determined the cause of the failure was unsupported gable trusses. The builder took immediate action to support the gable trusses and repaired them with new Master Wall materials.
