Technical Bulletin

MW# 170-080111

Topic: Efflorescence Considerations

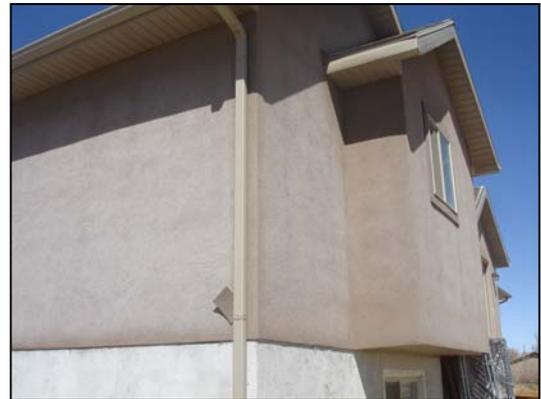
This home had "fading finish". It's not fading, it's efflorescence. Original color at downspout.

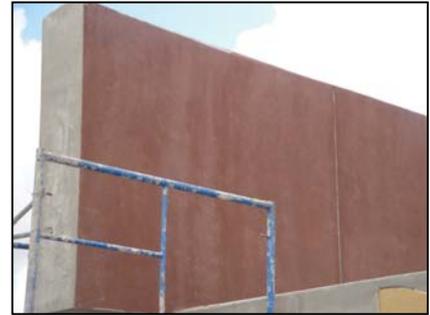
Uncapped wall lead to a streaky appearance on this dark color

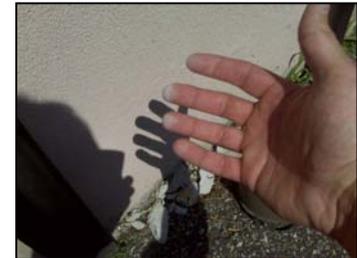
The typical field check for efflorescence is to rub your finger over the surface. If you remove white deposits it's most likely efflorescence.

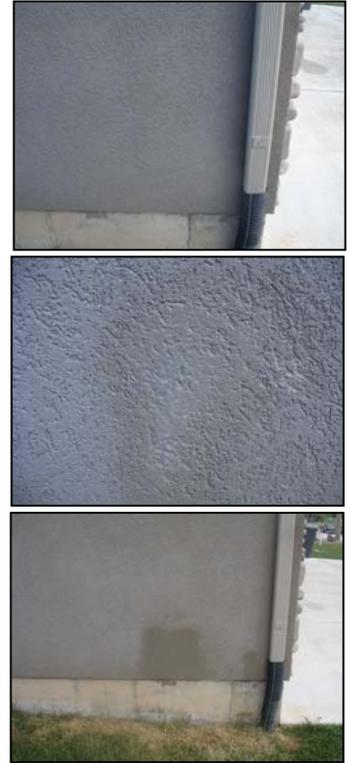
Top: Test Wall
Middle: Muriatic acid
fizzes on wall
Bottom: Dried and
restored finish

- ❑ Muriatic Acid: Safety precautions are definitely necessary and extreme care is needed if you're applying it over finishes (it can damage it and it won't be warranted). Dilute 1:20 and don't leave it on the surface long to avoid damage. Pre-wet the wall before application and rinse thoroughly.

Always pre-test cleaners in a small inconspicuous area. In all cases don't use a pressure washer, just a low-pressure pump. Work from top to bottom of the wall surface. At most leave the cleaners on the surface no more than 5 minutes or until fizzing stops. Allow to dry thoroughly before application of any additional products.
